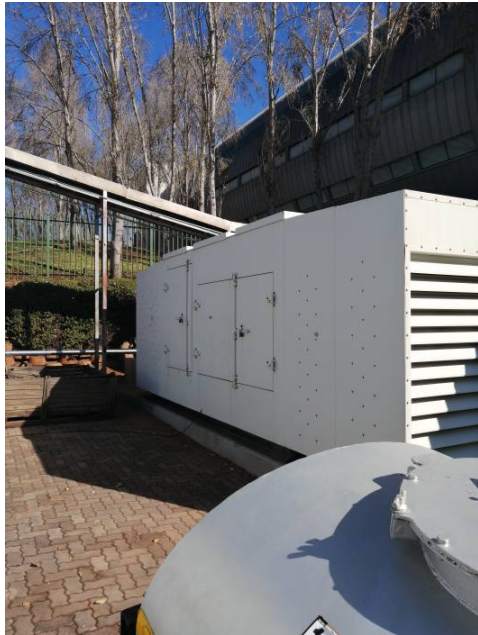
(21)

Fuel supply from on board service tank. No bulk feed connected

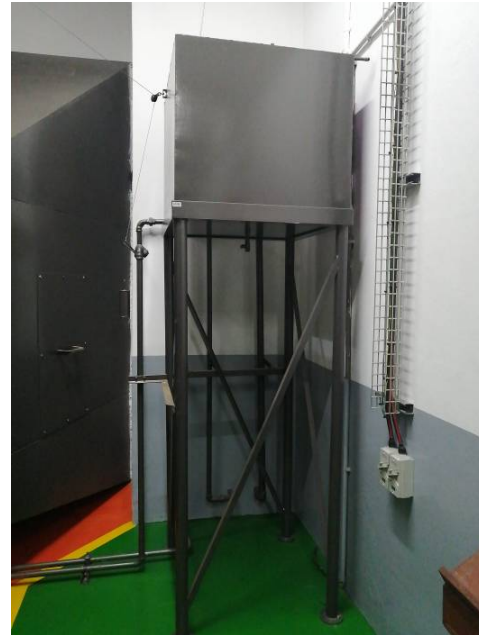
(22)

Area under tank to be bund. Bund volume to be 110% of stored capacity

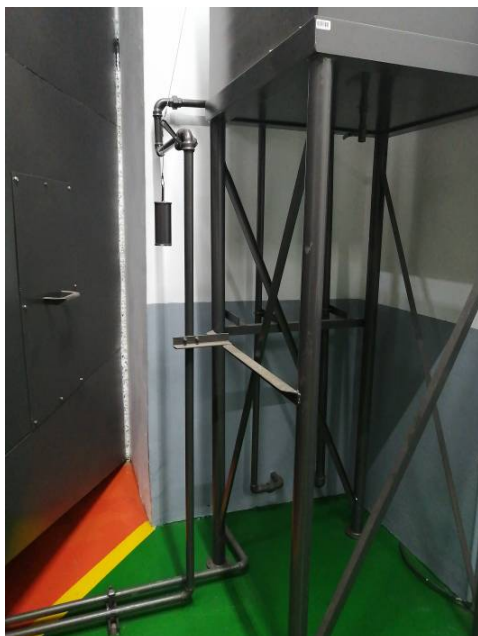
(23)

Area under tank to be bund. Bund volume to be 110% of stored capacity

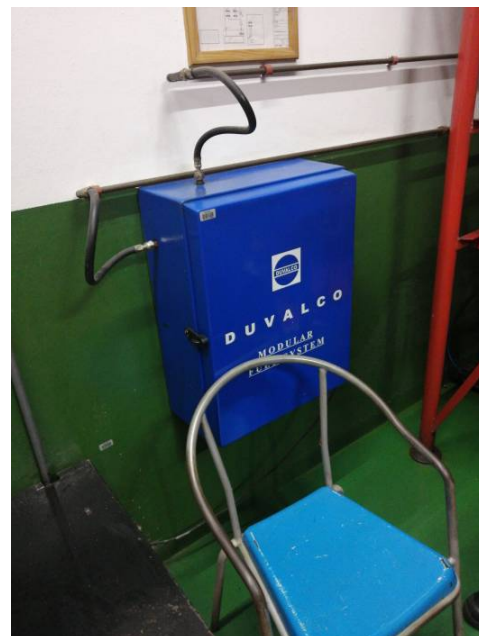
(24)

Filter system installed outside the bund area

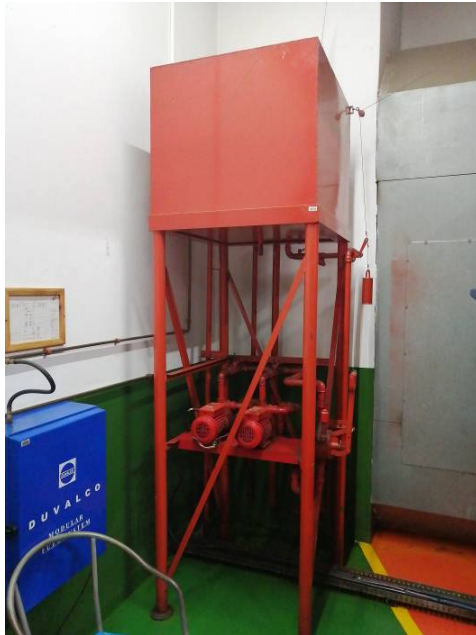
(25)

Area under tank to be bund. Bund volume to be 110% of stored capacity

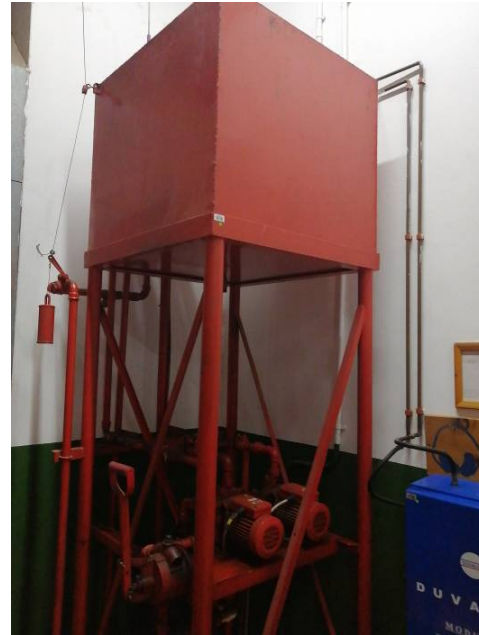
(26)

Filter system installed outside the bund area

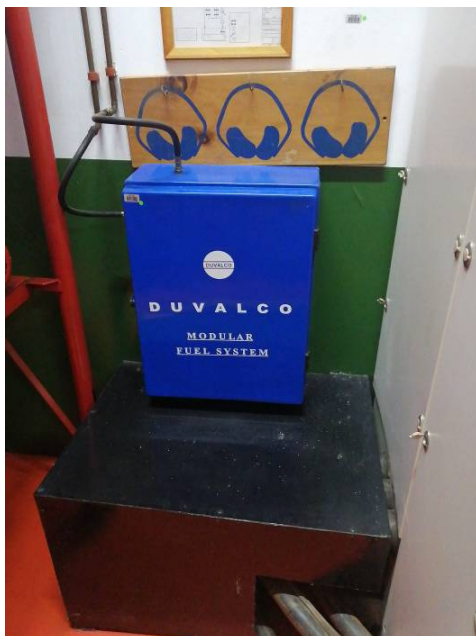
(27)

Filter system installed outside the bund area

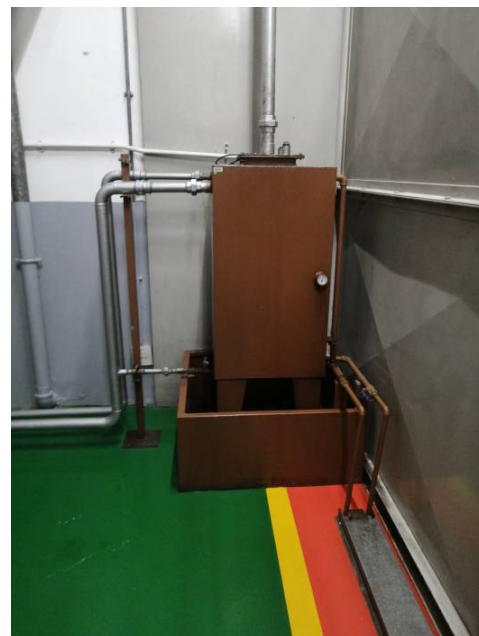
(28)

Shut off valve outside bund area. All tank shut off valve to be fire safe.

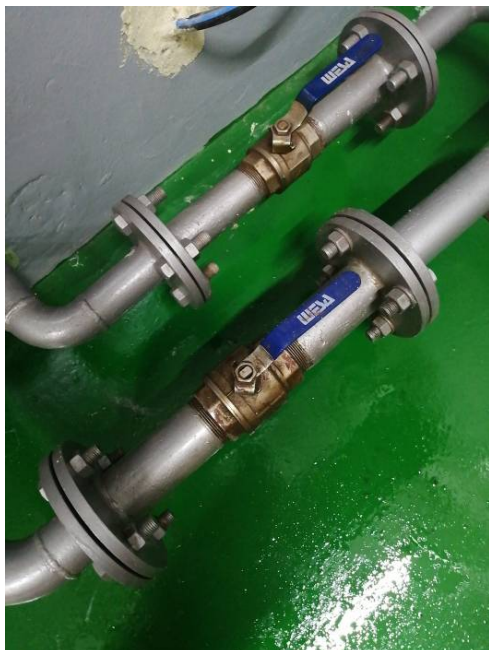
(29)

All shut off valve to be fire safe valves

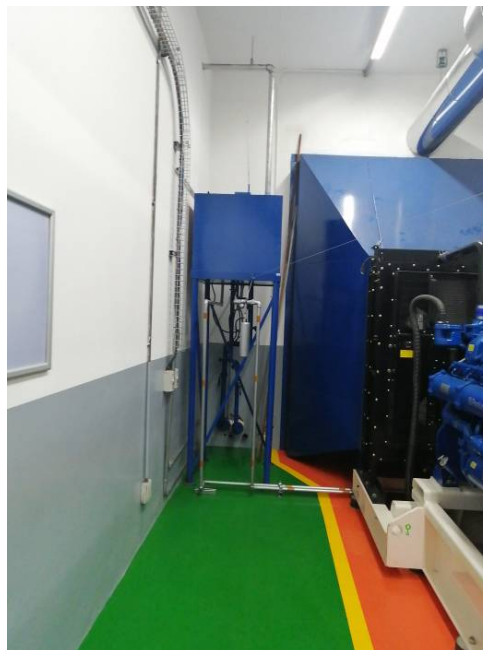
(30)

Area under tank to be bund. Bund volume to be 110% of stored capacity

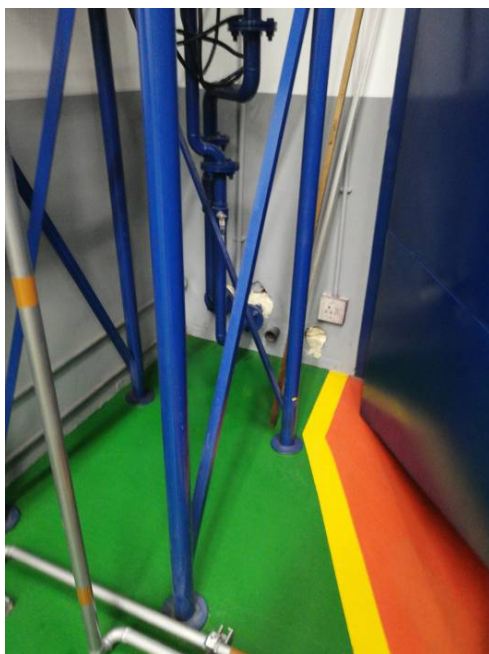
(31)

Plug point in zone 2 area.

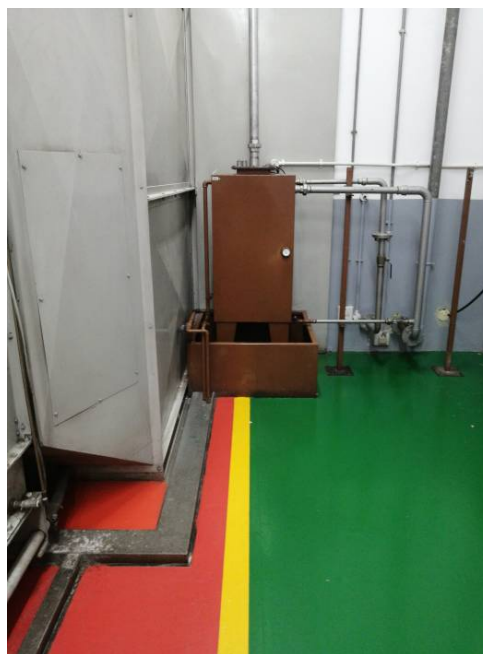
(32)

Plug point in zone 2 area.

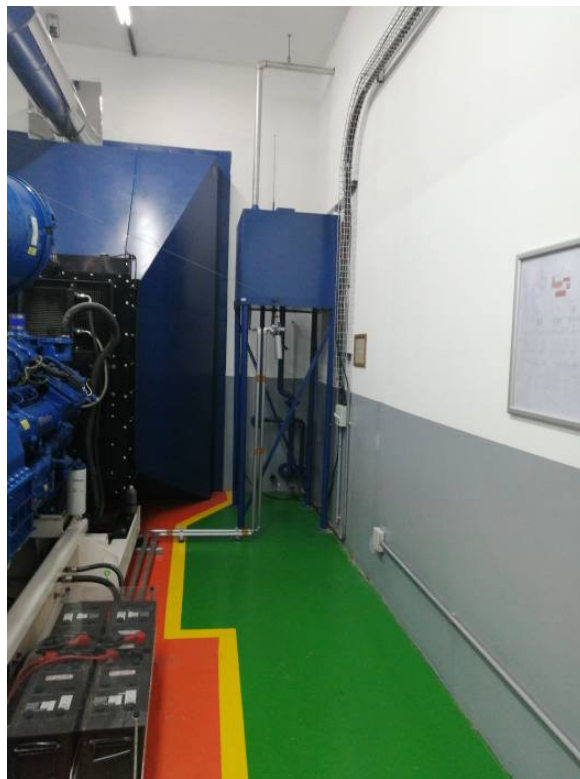
(34)

Area under tank to be bund. Bund volume to be 110% of stored capacity

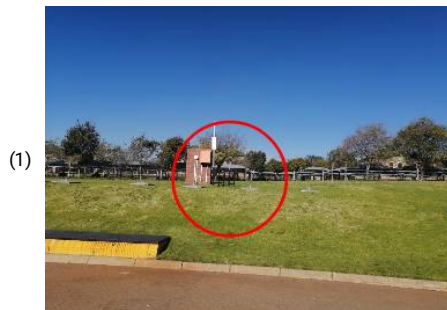
Comment header for all bulk storage tank. Each tank to be equipped with its own vent pipe.

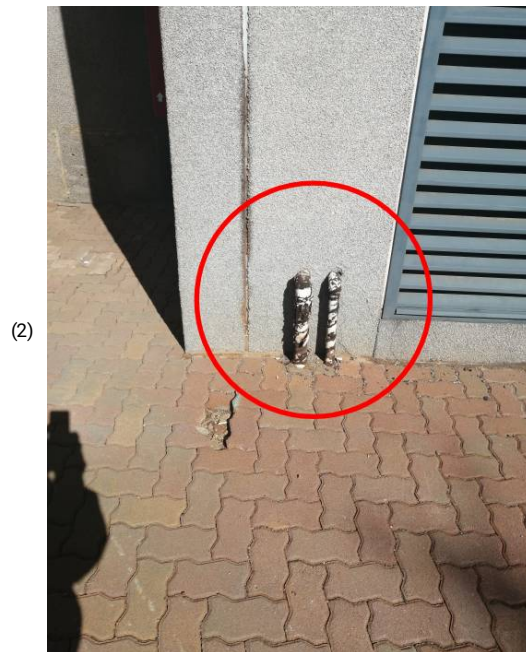
Diesel supply & return line densco wrap damage. Pipe corroded.

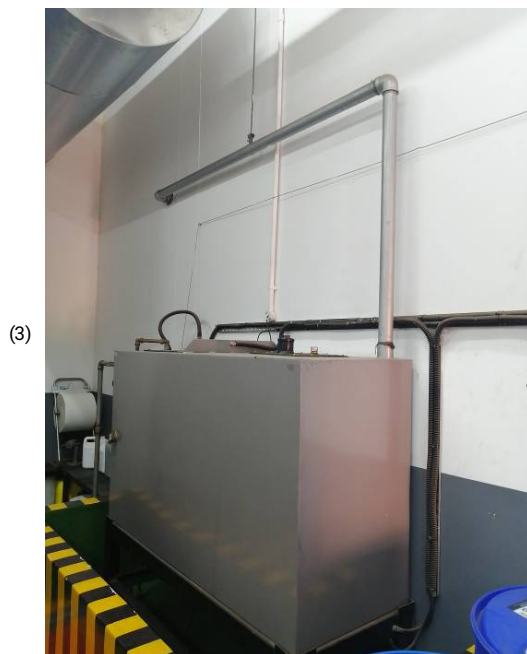
Vent pipe reticulated to next generator room.

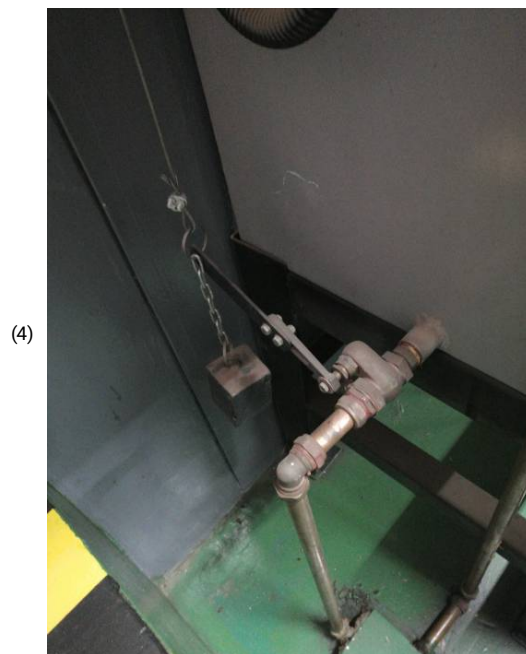
All valve in bund area to fire safe valved

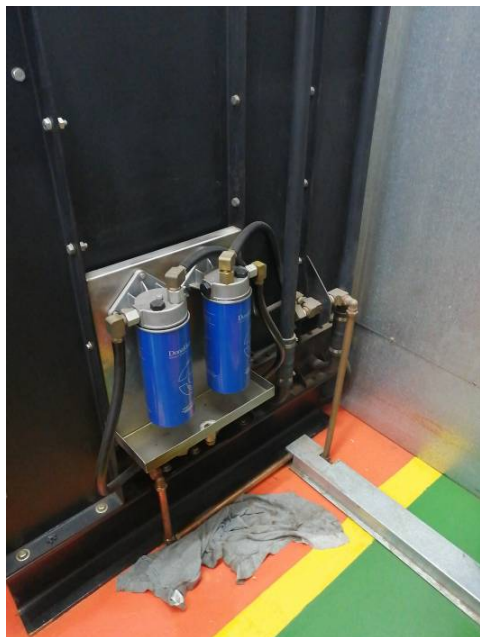
(5)

Filtration system outside the bund area. Fuel leak can cause a pool fire.

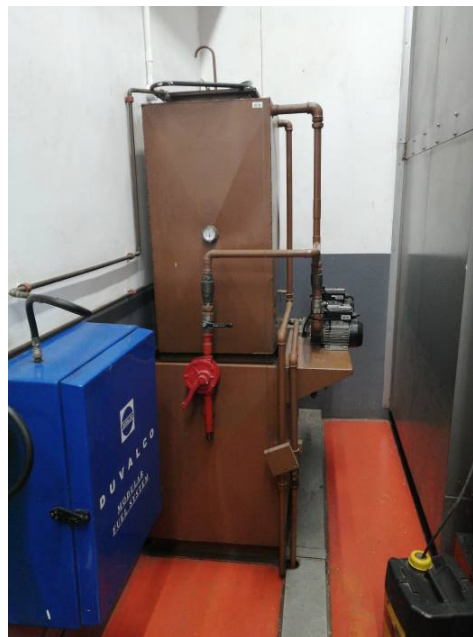
(6)

Filtration system outside the bund area. Fuel leak can cause a pool fire.

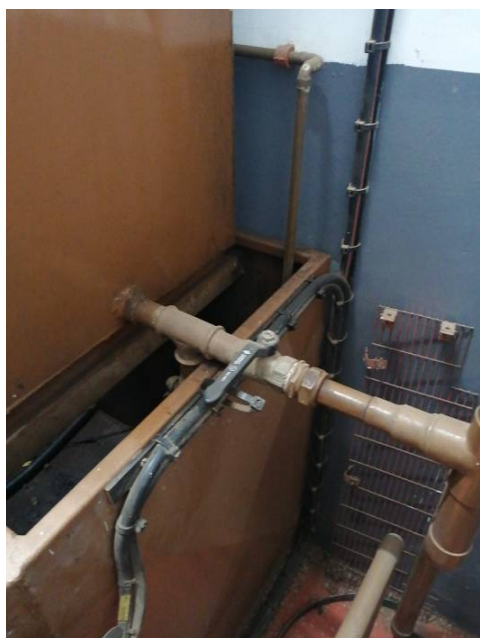
(7)

Shut off valve to be in bund area. Valve to be fire safe valves

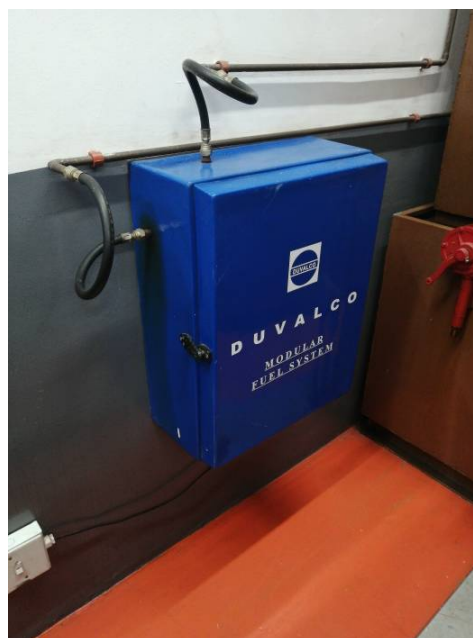
(8)

Filter system installed outside the bund area. Plug point in zone 2 area.

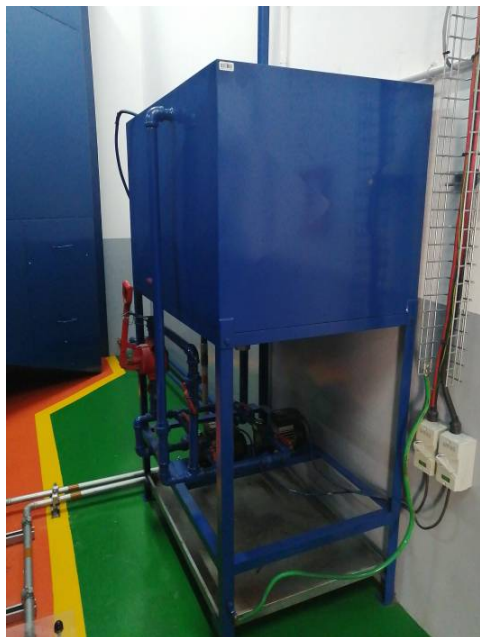
(9)

Area under tank to be bund. Bund volume to be 110% of stored capacity

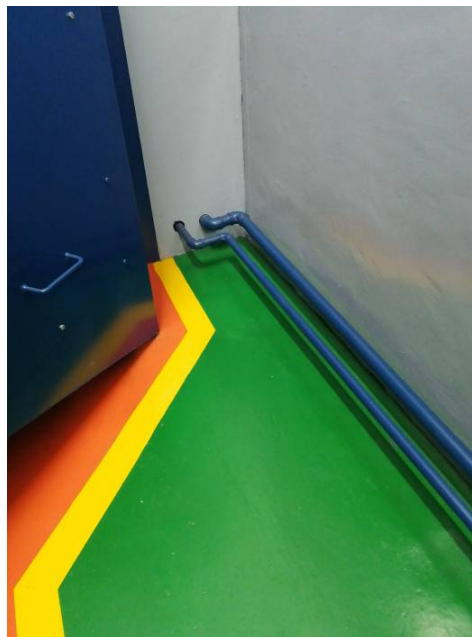
(10)

Piping color to be silver & banded with correct sulfur content

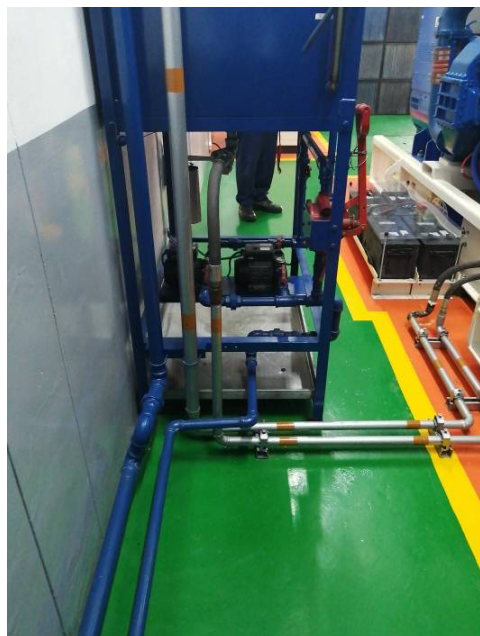
(11)

Area under tank to be bund. Bund volume to be 110% of stored capacity

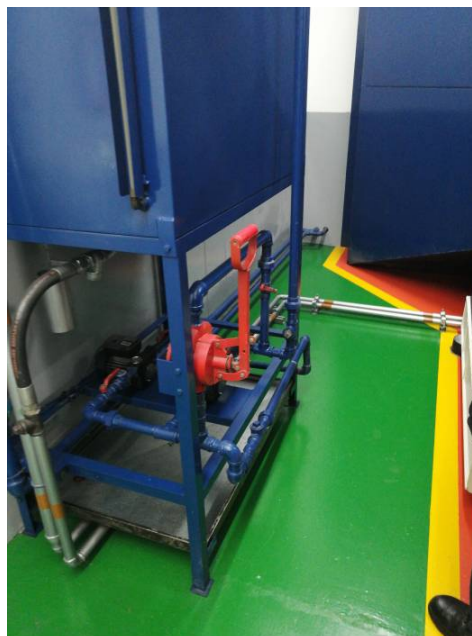
(12)

Area under tank to be bund. Bund volume to be 110% of stored capacity.

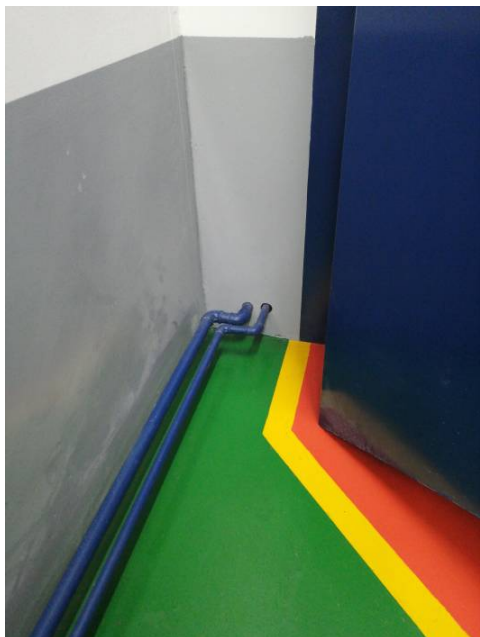
(13)

Piping color to be silver & banded with correct sulfur content

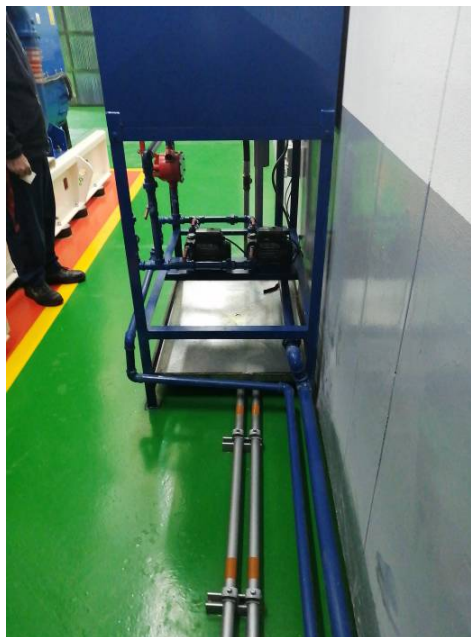
(14)

Area under tank to be bund. Bund volume to be 110% of stored capacity

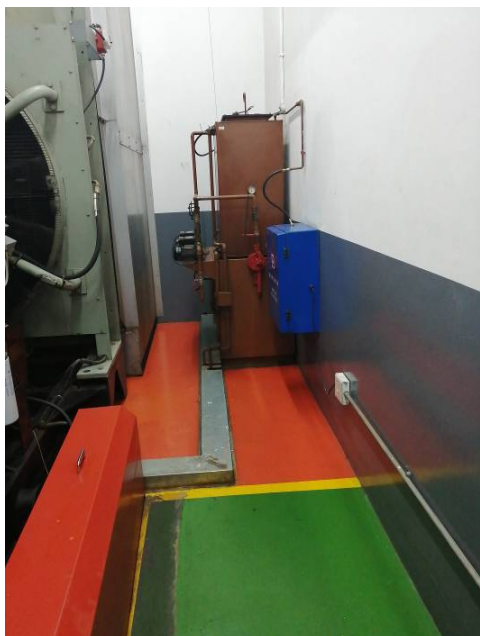
(15)

Filter system installed outside the bund area. Plug point in zone 2 area.

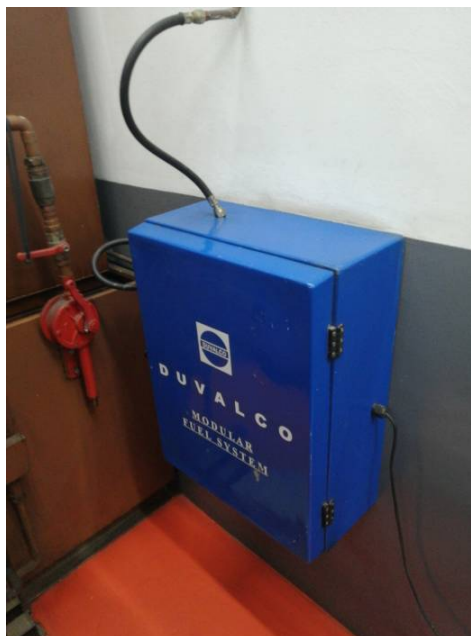
(16)

Filter system installed outside the bund area

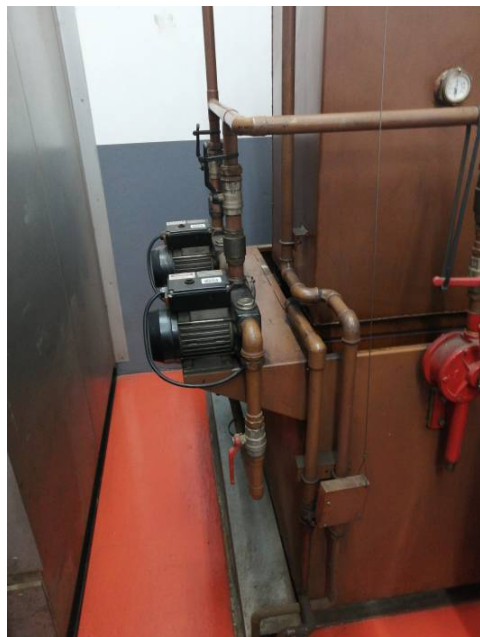
(17)

Filter system installed outside the bund area

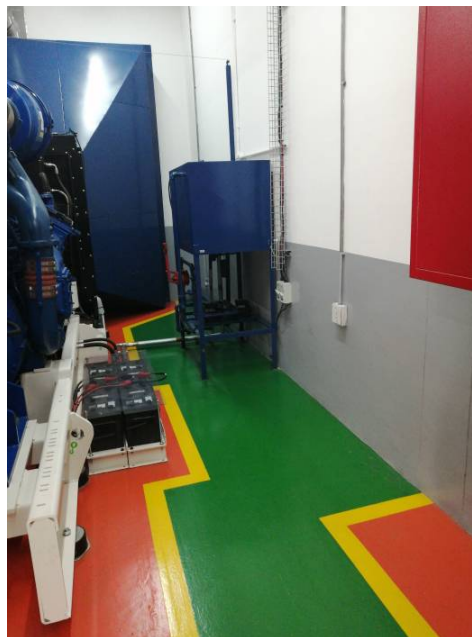
(18)

Area under tank to be bund. Bund volume to be 110% of stored capacity. Plug point in zone 2 area.

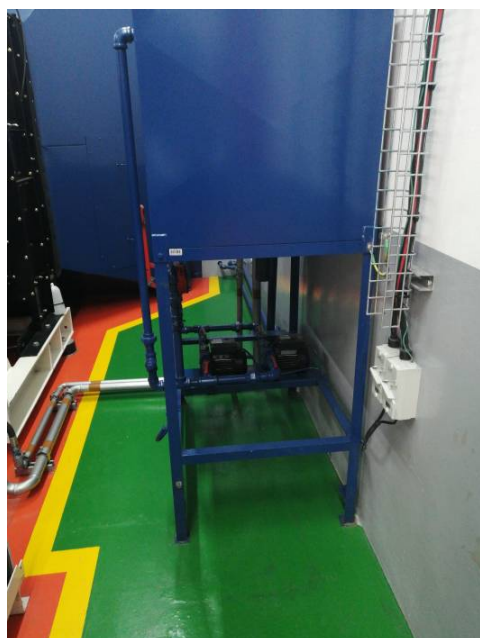
(19)

Area under tank to be bund. Bund volume to be 110% of stored capacity. Plug point in zone 2 area.

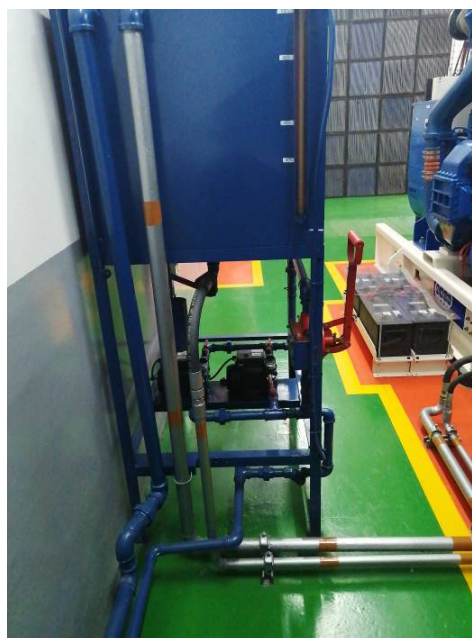
(20)

Area under tank to be bund. Bund volume to be 110% of stored capacity
